Raw Earth Architecture, an Adaptation Lesson in Distress. The Case of Khanguet Sidi Nadji ksar, Biskra, Algeria

NASRI.MANEL¹, FARHI.ABDELLAH²

Department of architecture, Mohamed KHIJEDER Biskra University, Algeria.

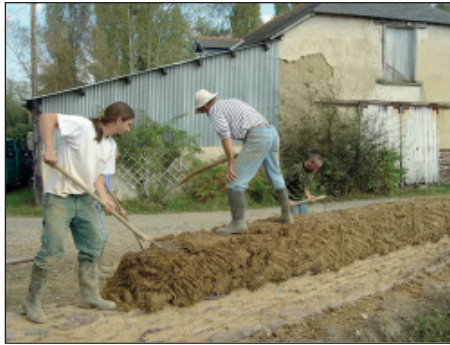
Figure 3. construction of a wall in bauge.

A massive earth construction technique where the earth, sometimes mixed with plant fibres, is piled up directly (without formwork) in successive layers running all around the building. This is a very old technique which probably preceded the adobe technique. The earth is similar to that of the adobes and prepared in the same way. The method of manufacture

is artisanal, and consists of manually modelling walls as they are built, by forming balls of earth approximately 60 cm high and thick. The material used is very clayey, and can be mixed with vegetable fibres or straw. The walls are usually load-bearing. (P. Pieux, 2012).

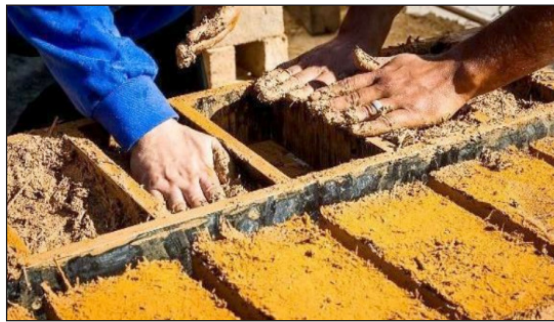
Figure 8. Manufacture of adobes. Source : P. Delot.2015.

Adobe is the most commonly used name for sun-dried bricks. Adobe bricks are moulded from moist clay soil. Originally, these bricks were formed by hand. Later (and still today), they are made by hand using moulds with various prismatic shapes made of wood or metal. Nowadays, machines are also used.

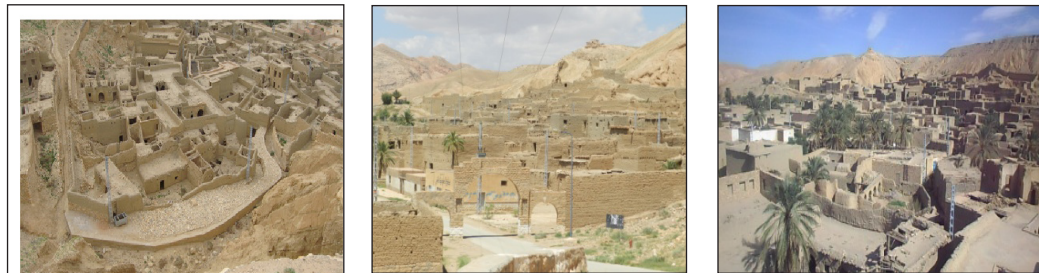
Figure 11. Some views on the ksar of khanguet sidi nadji.
Source : Author 2022.

The Ksar of Khanguet Sidi Nadji is a historic complex full of symbols and memory, with an architectural heritage of great value. This historic centre is now undergoing a process of transformation, degradation and rapid abandonment. The causes of this state of affairs are essentially due to the increased marginality of the Ksar in the urban structure of the city and in local planning. These conditions mean that the Ksar is abandoned to the various factors causing its degradation.

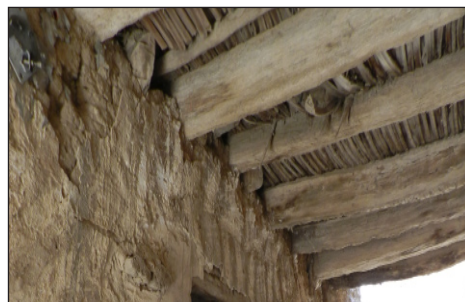
Figure 16. Example of a floor in the ksar of khanguet sidi nadjî. Source : Author 2019.

The roof or the covering of the houses is in the form of an accessible terrace, it receives most of the solar radiation, but its constitution plays the role of thermal insulation consisting of: “Khechbate” or palm beams formed by a quarter of a palm trunk, 2 to 2.5 cm in length, supported at their ends. This layer is then covered by a bed of Djrid (to avoid infiltration). A significant layer of earth is added last to consolidate the whole, which is 10 to 15 cm thick. The thickness of this layer depends on the location of the floor (first floor or terrace). The whole is protected by a waterproofing layer of whitewashed lime mortar.

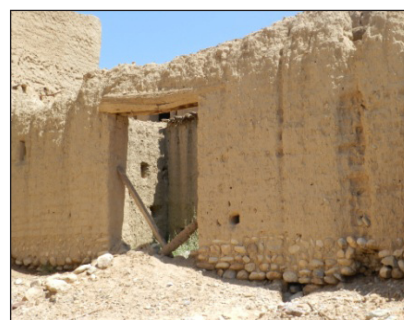
Figure 19. Erosion of the bottom of the wall in a building in the ksar of khanguet sidi nadjî. Source : Author.2022.

Rainwater flows directly into the alleys of the ksar, causing damage to the bottom of the walls. The stagnant water seeps into the wall due to the action of capillary rise. With time the wall loses its firmness and resistance and becomes fragile. It has been noticed that when the wall has a stone base it is more resistant.

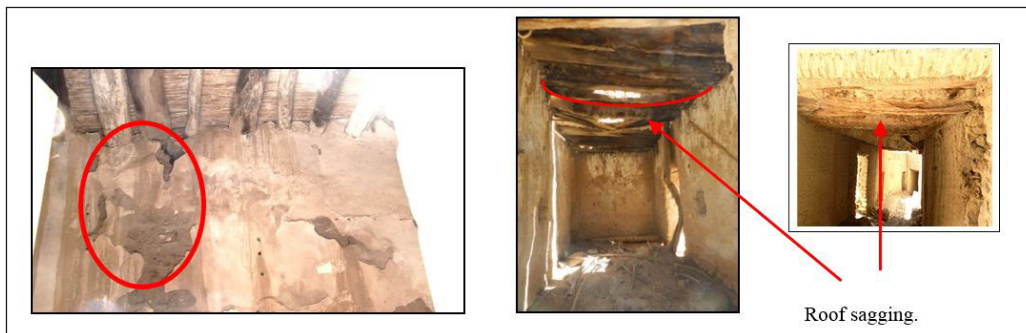
Condensation is due to an accumulation of moisture in the adobe equipment and under a waterproof plaster that is peeling off. Its action contributes to the weakening of the structure. The phenomenon appears mainly in the kitchens, where the beams weakened by rot end up

Figure 24. Trace of condensation with water run-off because of the bad junction of the beams and the wall. (Ksar of khanguet sidi nadji). Source: Author:2022.

Figure 25. TCondensation trace that affected the beams (black colour of the mould). It also caused the roof to sag. (Ksar of khanguet sidi nadji). Source : Author:2022.

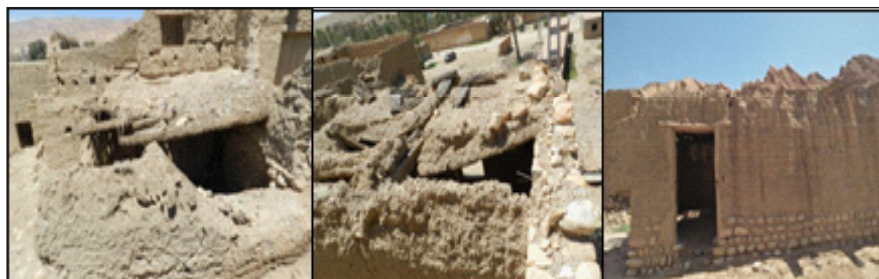
The poor condition of the unprotected acroteria has caused the mortar between the gargoyles and the walls to deteriorate. The gargoyles are poorly made and unprotected at their exits, which means that water not only seeps into the wall, which is the greatest danger, since the infiltration is not apparent. But it also runs over the surface causing an apparent crack which, over time, makes it fragile and destabilises it.

Figure 26. Degradation of the wall - detachment of the plaster of the interior space and the façade - erosion of the head of the wall. (Ksar of Khanguet Sidi Nadji). Source : Author 2022.

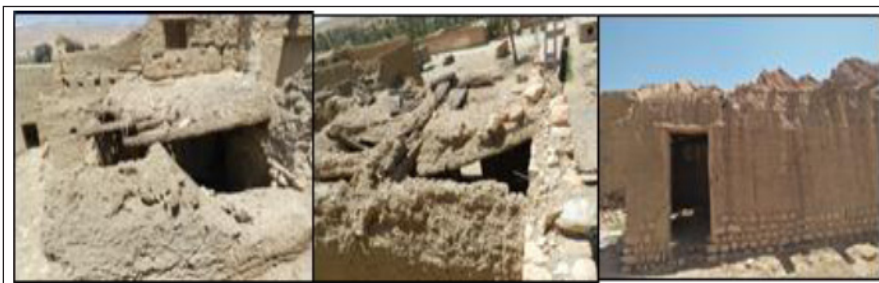
The slopes are not respected when the roofs are built, which causes rainwater to be retained. In addition, there is a risk of collapse due to overloading caused by the accumulation of soil. On the (Fig.27), the roofs of the buildings have suffered a lot of damage due to these two phenomena. The irregular shape of the mud bricks, mainly due to the mould of the Touba (adobe) itself, favours overlapping joints and sabre cuts, especially as the vertical joints are never filled.

Figure 27. Degradation of the roofs of the houses due to the retention of rainwater. (Ksar of khanguet sidi nadji). Source : Author:2022

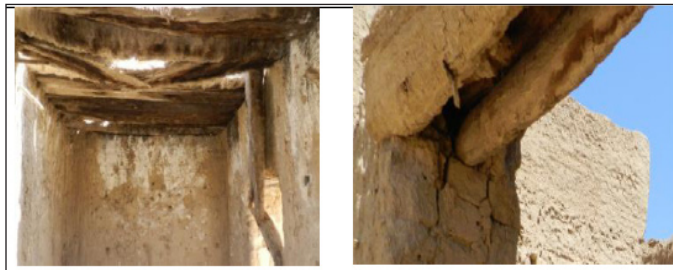
Wood material is also subject to water damage. This can take different forms. First of all, wood rot occurs when there is a constant presence of moisture either inside or outside the building (immediate environment). This situation creates a favourable climate for the development of micro-organisms and insects that cause the degradation of the wood, it should be noted that the parts embedded in the wall are the most affected by this phenomenon. Secondly, we have the loss of solidity of the wood due to dimensional variations. This occurs when water stagnates in contact areas (junction points) between the masonry and the wood. (Y. Baret, 2014).

Figure 28. Deterioration of palm wood due to water retention. (Ksar of khanguet sisi nadji).

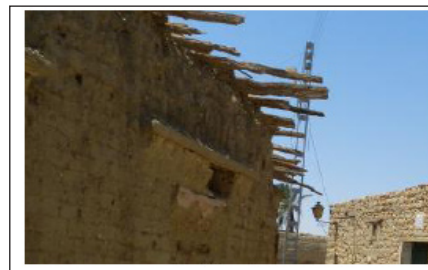
Deterioration of structural wood due to poor embedding

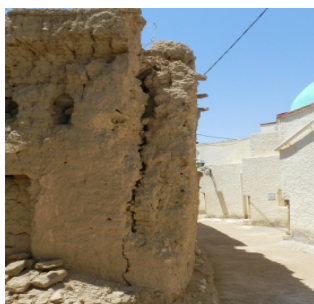
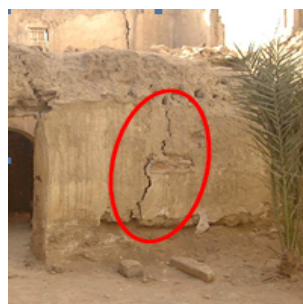
- Formation of bellies under the effect of the thrusts (differential terminal settlement), this is explained by the uncoupling of the wall due to a bad chainage (Fig.30 -(a)).
- Crack formation and according to their size we can distinguish between microcracks, cracks, fissures or crevices.
- Punching cracks due to poor load distribution (weight of the roof or floor). (Fig.30 -(b)).
- Shrinkage cracks in some adobes caused by long periods of drought (Fig.30 -(c)).

Figure 30. a). Passing crack due to differential settlement. Sabre stroke (Ksar de khanguet sisi nadji). b). Inter-intermediate differential settlement. (Ksar of khanguetsidinadji). c). The removal of mud bricks. (Ksar of khanguet sisi nadji).

In the case of cracks, before any repairs are carried out, the origin of the problem must first be determined and remedied in order to stabilise the structure. Depending on the degree of the pathology, there are several types of interventions, such as: tie rods, wooden chains. It is recommended to install them at equal intervals, figure n°36 shows the detail of the key, it is made of wood, consisting of male and female pegs. Once the keys are installed, the cracks are filled in and then covered with earth and straw mortar, taking care to fill in the remaining spaces between the key and the wall.

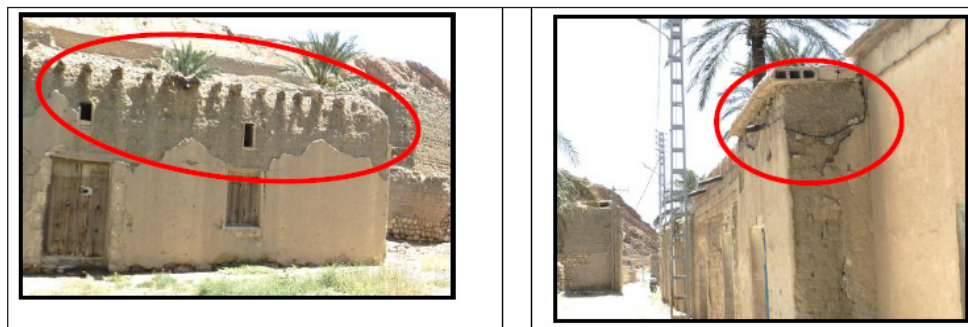
or external drain, waterproofing of the roof, etc.), eliminating the stone bases and removing the roofing. The damage caused by this process is reflected in the detachment of recent plasterwork, the loosening of adobe courses and the opening of breaches.

Figure 31. Detachment of the plaster due to the use of waterproofing materials unsuited to the properties of the adobe. (Ksar of khanguet sidi nadji). Source : Author.2022

In order to re-establish the plaster, the traditional technique par excellence is recommended on a bare and pitted support. The mortars used can be homemade or ready-made but must have a decreasing dosage of binder. The first layer, called «gobetis», regulates the porosity of the masonry support and ensures the adhesion of the subsequent layers of rendering. Sprayed in a 5 mm thick layer, the surface of this mortar with a high proportion of binder must remain rough to facilitate the adhesion of the second layer. It is necessary to wait at least 48 hours before applying the second coat which forms the body of the rendering. Applied on the re-wetted base coat the day before, the 15 to 20 mm thick rendering body is applied in two or more passes, levelled with a ruler, tightened with a float but not floated to preserve its roughness. It is used to waterproof and straighten the support. The cumulative thickness of the first two coats must be between 15 and 20 mm and ensure an overlap of at least 10 mm at all points. After a minimum of 7 to 9 days of drying, depending on the nature of the binder of the rendering, the last stage consists of a finishing coat of 3 to 7 mm thick, applied in one or more passes depending on the type of mortar and the desired appearance (floated, smoothed, structured, etc.).

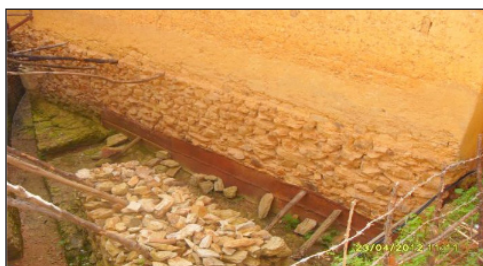
Figure 32. Peripheral drain. Source : I. Kadoui et al, 2015.

Figure N°32, taken in Maatkas (village of Ichaouadienwilaya of TiziOuzuo), illustrates a peripheral drain. According to the owner, its installation is the solution to finish with the rainwater infiltrations from which his house was suffering. To do this, the owner first stripped the soil beneath the wall and removed both the vegetation and the waterproof paving. Finally, he made a sloping trench and a gutter to channel the water to the main drain. As a safety measure, the owner installed a wooden barrier to act as a guardrail for passers-by (I. Kadoui et al, 2015).

The remedy against humidity in this case is the installation of a perimeter drain, which is a device that controls the humidity present at the foot of the wall. The system consists of intercepting rainwater and preventing it from reaching the base of the walls, channelling it to a drain connected to the rainwater network. (Collombet et al, 1989).

The primary purpose of the perimeter drain is not to evacuate water but to allow the foot of the wall to dry. It favours the ventilation of foundations in an environment where there is little exchange. It is recommended that the base coatings be formulated differently so that they are both «breathable» and impact resistant. A little pozzolan can be added to improve their performance.
