# Impact of Urban Planning Instruments on the Conservation of Built Heritage in Algeria. Case Study: Old City Center of Biskra

## Abstract

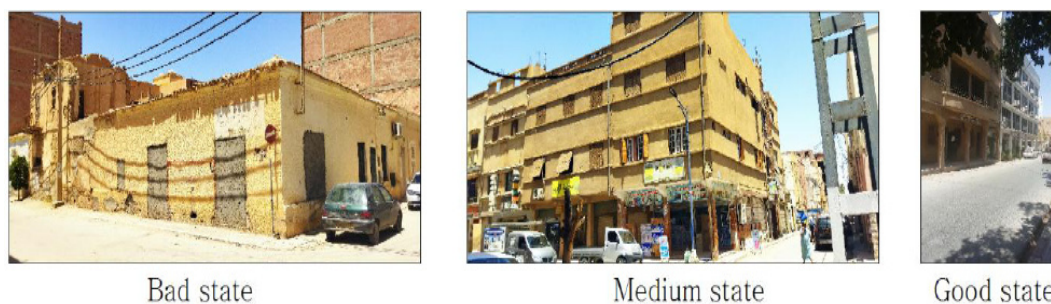
**Figure 6.** Buildings classification made according their state (Source: Author, 2022)

Our field survey allowed us to reclassify all the buildings in the studied area according to their state (bad, medium, good) (Figure 6). The bad state concerns the old and precarious buildings. The medium state concerns the old buildings from the colonial era that have been maintained as well as those built after independence (1970s and 1980s). Buildings in good state are those that have been recently built (for example, in the last 10 years), renovated or restored.

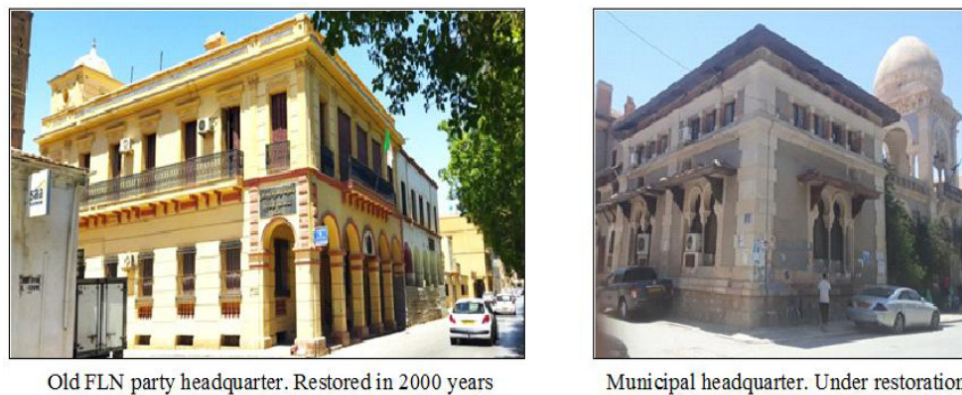
**Figure 8.** Rare examples of restoration in the Old Colonial neighborhood. (Source: Author, 2022)

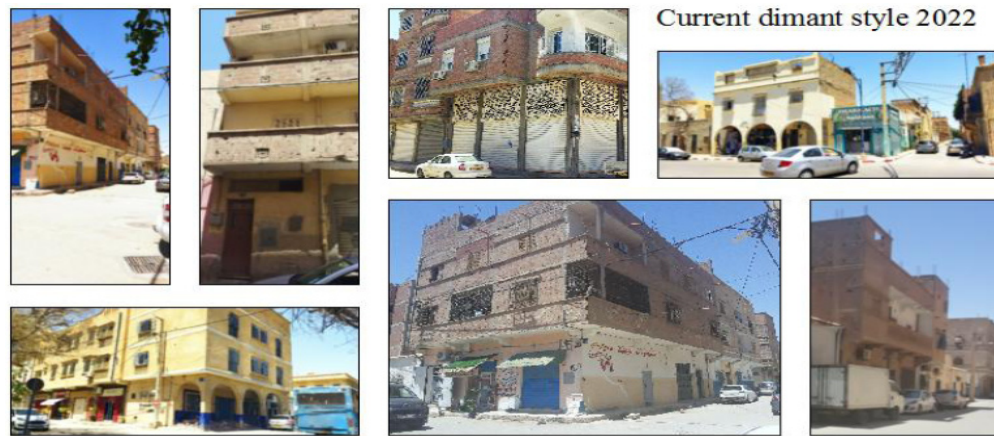
**Figure 9.** Actuel dominante facade architectural typologie . (Source: auteur 2022)

This typology is characterized by a superstructure in reinforced concrete post and beam system. The ground floor is generally occupied by garages or commercial premises. The balconies run along the entire width of the facades. In many other cases, the intermediate floors are moved forward by one meter on the street in order to increase the surface area on the upper floors. Openings in the form of doors or windows all barred without any previous order or style. No concern is given to decorative or ornamental details that could give character to the facade elements (Figure 9).

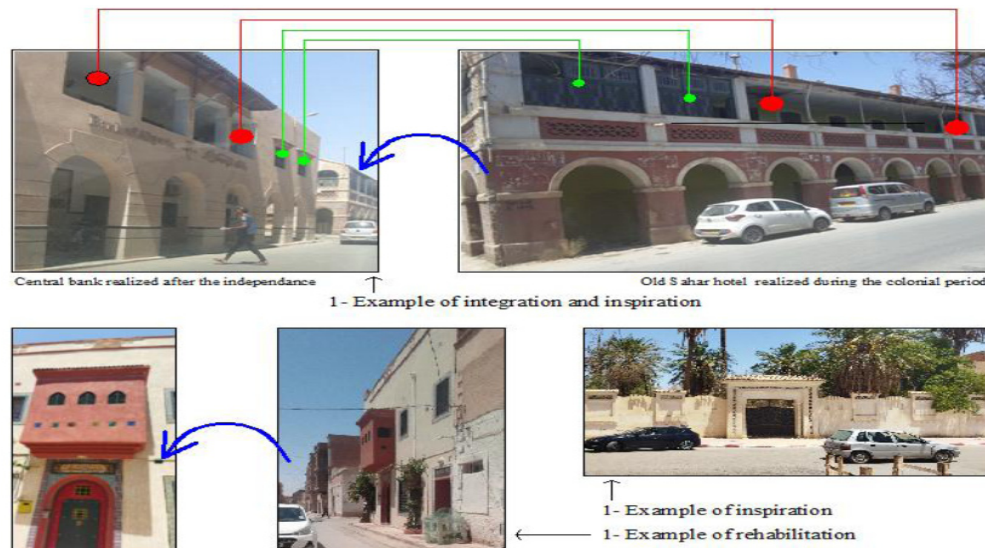
**Figure 10.** Rare examples of building heritage enhancement at the façade level. (Source: Author, 2022)

This propagation has accelerated the disappearance of the old colonial style that we consider as a heritage that must be protected. Very rare are the cases of buildings where we see the presence of interest towards this valorizing inspiration is noted. They are currently in number of 03 (figure 10).
