Urban Planning Violations in the Planned Districts: The Case of the District of 120 Dwellings in the City of Tebessa, Algeria

This work aims to diagnose construction violations in the neighborhood of 120 dwellings located in the southwest of the urban perimeter of the city of Tebessa. Is one of the regular planned neighborhoods in advance, however, it has been affected by construction violations in its various forms and images in light of the lack of feasibility of legal procedures in the face of the phenomenon .

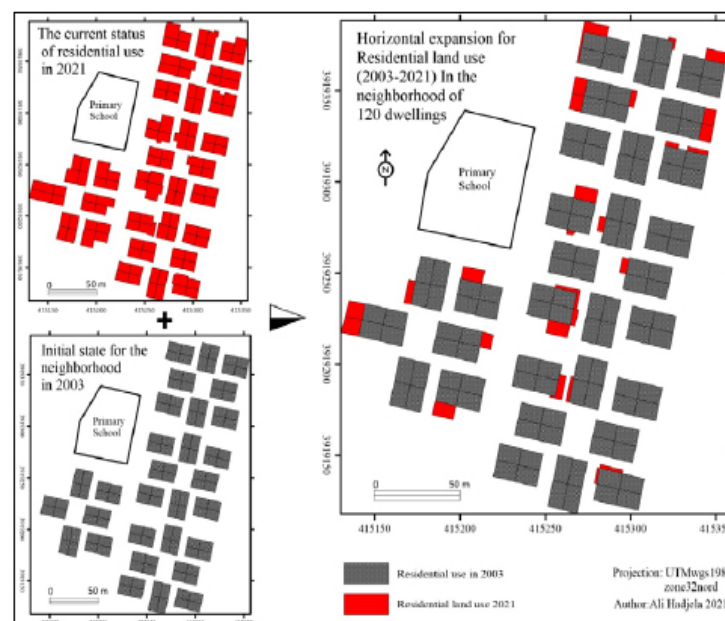
Figure 6.Horizontal expansion for residential land use (2003-2021).

By comparing the uses of residential land between 2003 and 2021, it is noted: the increase in the area occupied by housing moved from 1,43 hectares to 1,57 hectares see (Figure 7.) , an increase of 10,33%, In contrast, there is a decrease in green spaces and parking spaces, which moved from 3,48 ha to 2,74 hectares, or about 21.06% and if we remove the fenced green spaces (reserved) for the purpose of expanding at their expense, estimated at 951,64 m², then their area will decrease by 49.54%.

We previously referred to the complexities that characterize the residential use area, due to the changes made by the residents to the buildings see (Figure 6.).This is confirmed by the increase in the average area of one house in 2021 to reach 131 m² on average, compared to 119 m² for one dwelling on average in 2003, which is evidence of the expansion process that Residential buildings define illegally, as well as the high value of the standard deviation [6] of housing areas in 2021, which is estimated at 26.79 m², compared to its value in 2003,

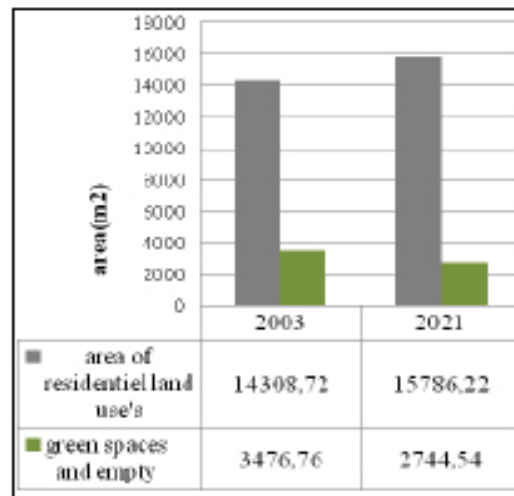
Figure 7. Increasing residential area and decreasing green and empty spaces

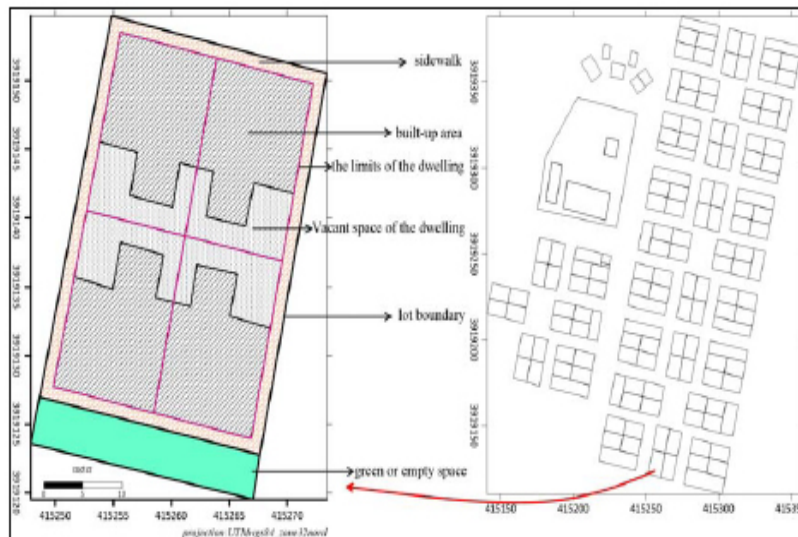
Figure 9. Components of a plot of land built in the neighborhood of 120 dwellings.

When calculating the coefficient of land acquisition (CES) for a plot of land (the figure below), we found that it is equal to 0.6 according to the initial situation for the year 2003, bearing in mind that the characteristics of this plot are: The number of dwellings is 04, the built-up area of the four dwellings : 328 m² The vacant area of the four dwellings is 124 m² The vacant or green area of the land plot: 64 m², the sidewalk area: 30 square meters, and from that, the total area of the plot is 546 m² and the CES is equal to: 328/546 and given that the horizontal change in residential areas amounted to 10.33%, CES = 0.66 in 2021. As for the coefficient of soil occupancy COS, it was equal to 0.6 in 2003 and it has known a change of up to 1.05 in some plots of land that include three-storey buildings.

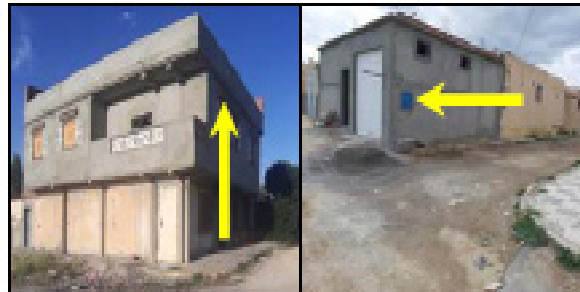
Figure 14 . Vertical and Horizontal expansion and violation of COS and CES (photos taken: March 2021).

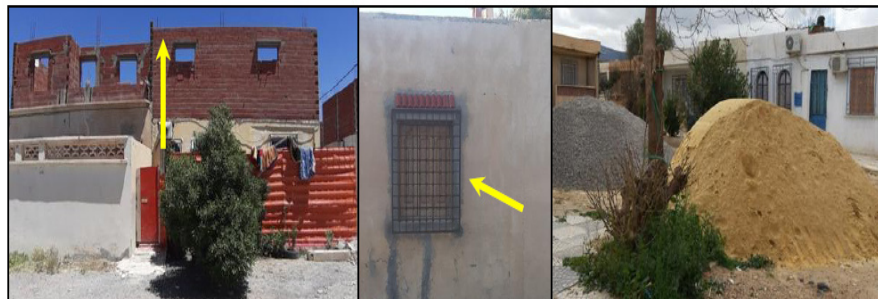
Figure 15. Vertical and horizontal expansion, Created new windows, and Putting building materials on the road when building workshops are opened (Photos taken: March 2021).

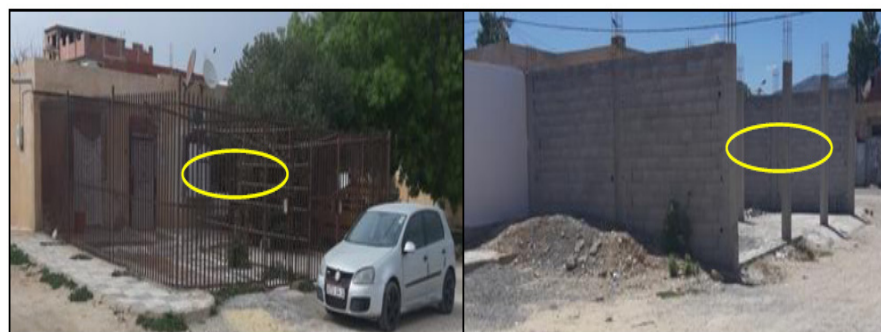
Figure 16. Fence made in front of the house, Integrate and build the side space (Photos taken: March 2021).

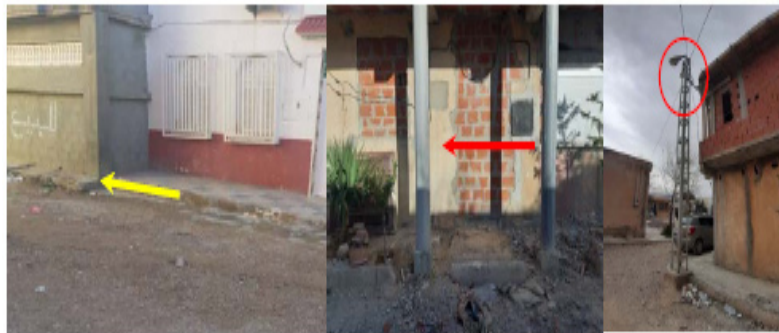
Figure 17. Extension on the sidewalk, change of facade, construction near the electric pole(Photos taken: March 2021).
