Assessment of Quality of Use in Collective Housings, Case Study: Collective Housing of Social Formula, 700 Dwellings, Khenchela City, Algeria

Ansar Ahmed Mounir¹, Adad Mohamed Cherif², Hamdaoui Abdeldjalil³

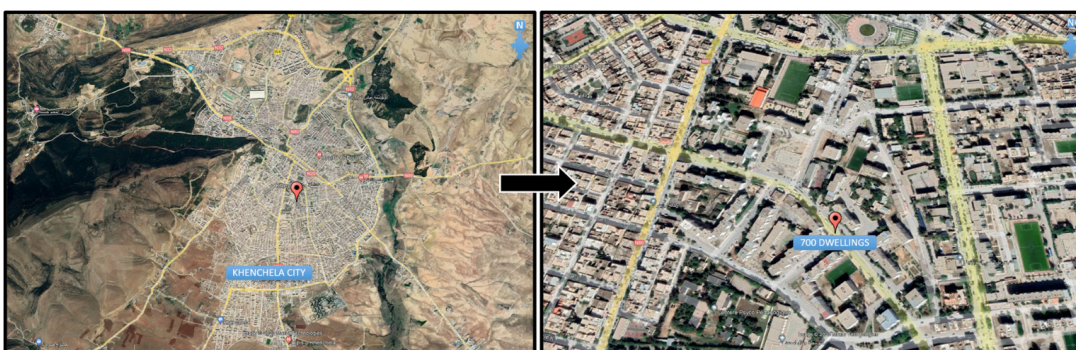
Figure 2. The geographic location of the 700 dwellings. Source : Google Earth 2022.

The following part demonstrates the investigated case study, in which we will be evaluating the quality of use. The 700 dwellings are a housing project located in the center of Khenchela city (Figure 2). The city is located in the high plateaus area, northeast of Algeria (Figure 1).

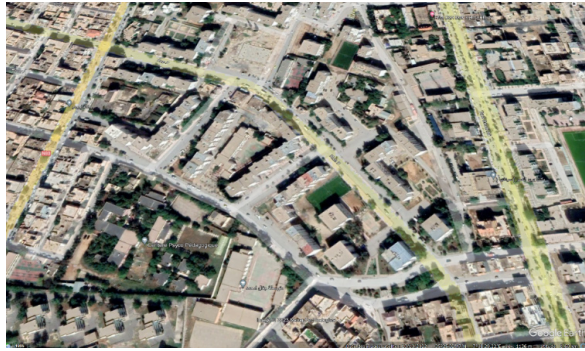
Figure 3. Urban layout of the 700 dwellings.
Source : Google Earth 2022.

The 700 dwellings are located in a high-density area of the city, they are surrounded by residential neighborhoods and other dwellings. The site is well-identified by many landmarks (administrative buildings and schools). This housing project was built in 1978 and inaugurated in 1980. The urban layout was very basic. Apparently, the plan was just to extend and connect the surrounding streets. The placement of the buildings was mainly done in such order to accommodate the construction crane (Figure 3).

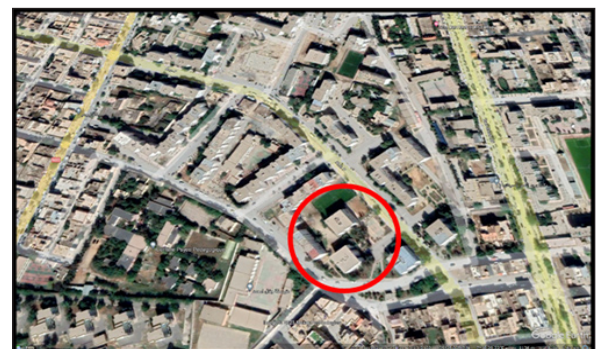
Figure 6. Urban layout of the 700 dwellings. Source : Google Earth, 2022.

This shows that the majority of the residents questioned were contented with this criterion, due to the fact that the urban integration is well accomplished owing to the circumstance that the dwellings are in the center of the city with a high density surrounding, despite that the urban layout was not very well thought of (except for the building shown in (Figure 6)).

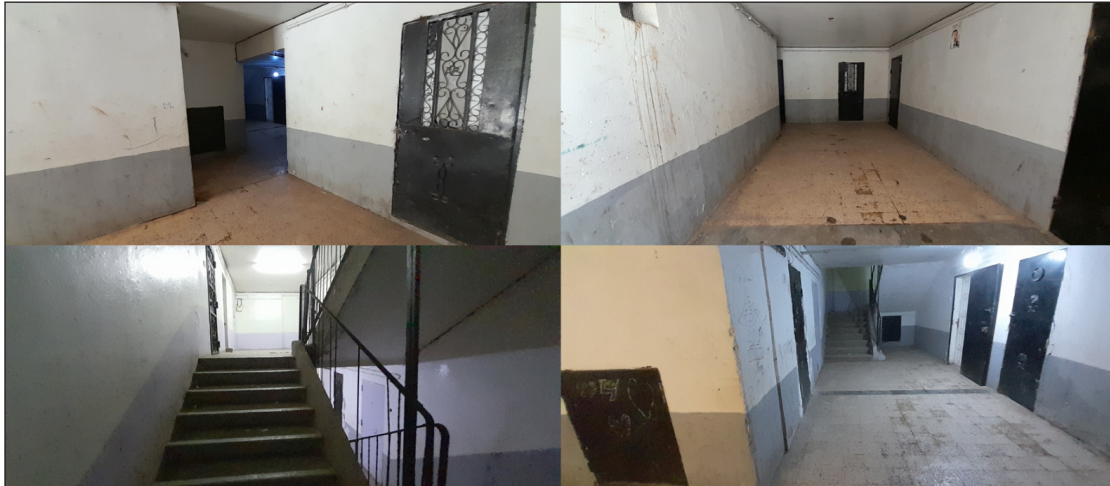
Figure 9. Main entrance's hallway and staircase. Source : Author, 2022.

This displays that, even if the urban integration was very well thought of, the entrance of the building remains a vital factor for the residents, and the fact that every single resident that either attested "bad" or "very bad" in the questionnaire, also expressed a major disapproval regarding the dimensions, lighting, hygiene and even safety of the entire entrance (hallway and staircase included), moreover (Figure 9) supports that.

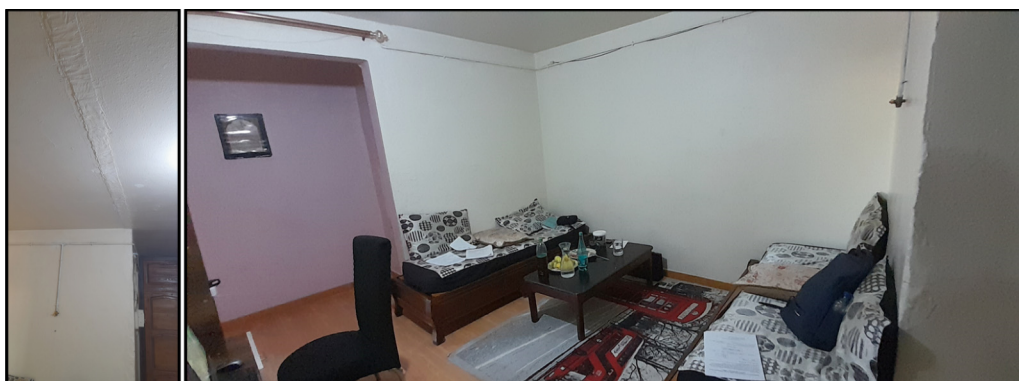
Figure 11. Modification made by residents: tearing down a wall to widen the living room. Source : Author, 2022.

To continue, concerning the architectural organization criterion, the residents were first asked about the functional disposition of their housing, to which 54.2% answered by “yes” and 45.8% answered by “no” (Figure 10), this shows that half the residents are pleased with the functional layout of their housings. But then again, when they were asked about their satisfaction regarding the dimensions (area) of the different spaces, the half that answered by “yes” previously expressed they were “satisfied”, correspondingly the other half that answered by “no” expressed they were “dissatisfied”, besides the 8.3% of “neutral” responses. As a matter of fact, the only modification made to the layout was actually to widen a space (the living room), as it’s shown in (Figure 11).

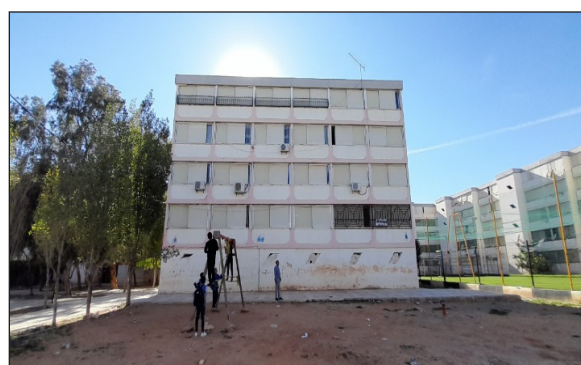
Figure 13. North facing front shows no direct sun light exposure even in mid-day. Source : Author, 2022.

This demonstrates that, the majority of the residents are unfulfilled with the natural light supply indoors, especially since the ones that are in fact fulfilled, their housing is oriented to the east and the south. Whereas, the disapproving ones, are oriented north and west; as shown in (Figure 13) this particular front, with several windows, is north facing (the picture was taken in mid-day).

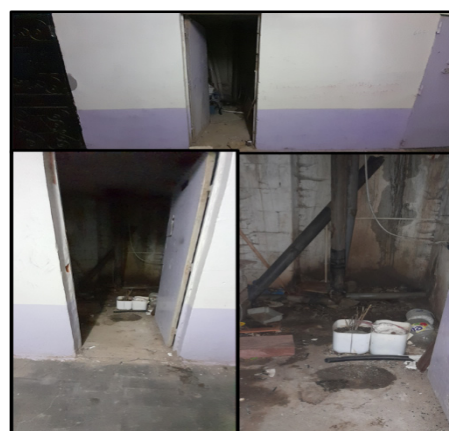
Figure 15. The sewer system exposed and badly maintained. Source : Author, 2022.

This only proves that poor air quality is present, considering that the residents affirmed: “bad odors originating from the sewers often blocked”. (Figure 15) highlight the precedent statement.

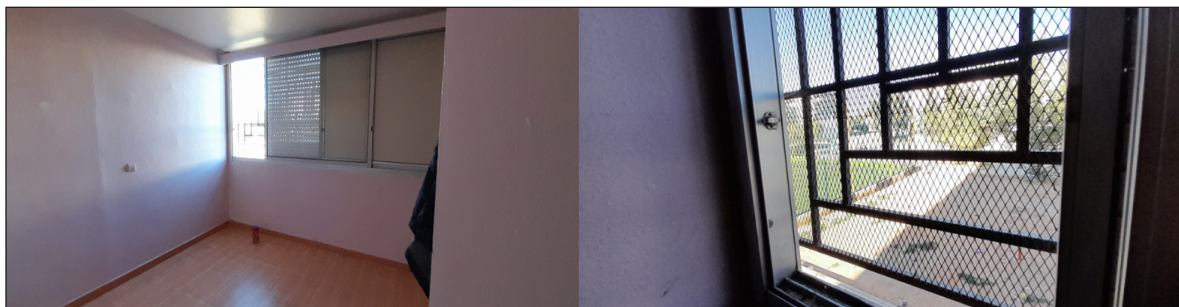
Figure 18. Large windows along the front wall, with no acoustic isolation. Source : Author, 2022.

The large windows along the front wall, seem to be lacking any form of acoustic isolation as shown in (Figure 18).

This goes to prove that, the low-cost nature of the collective housing of social formula, is affecting a large portion of the residents' life quality and well-being. Because, a simple acoustic isolation could go a long way in improving the said quality.

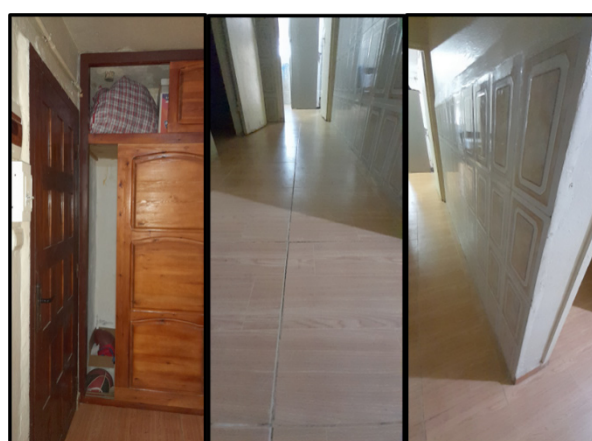
Figure 22. Materials modifications (replacements) by the residents. Source: Author, 2022.

When it comes to, materials appreciation, the residents plainly expressed their disapproval by a staggering percentage of 95.9%. Moreover, the vast majority of that 95.9% of residents revealed making modifications (replacement) to several materials including floor tiles, wall tiles (bathroom and kitchen), and wood carpentry (Figure 22).

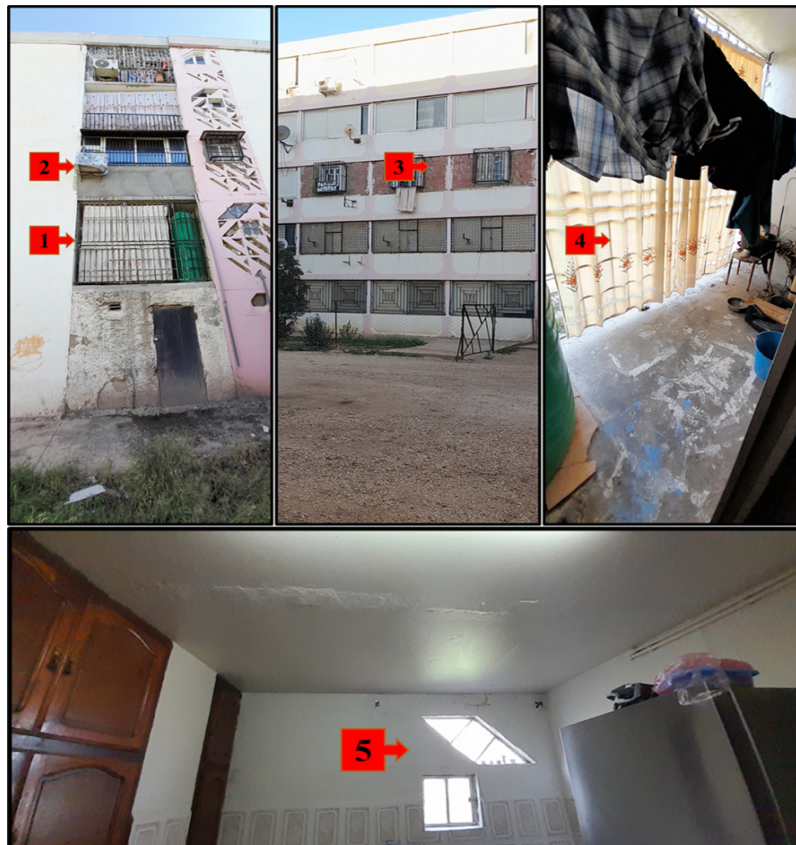
Figure 24. Modifications made by the residents to adapt their housing to their cultural needs. Source : Author, 2022.

As exhibited in (Figure 24), the residents made a significant number of modifications to accommodate their needs. And by doing so, they are adapting the architectural design to their behavior and special requirements. As it shows, points 1 and 2 of (Figure 24) display the removal of the wide opening of the balcony. While point 2 was successful in doing so, by narrowing down the wide opening to a normal size window, point 1 only used a curtain to preserve privacy (point 4 shows more details from the inside). As for point 4, a more radical approach was used, the picture shows that the resident eliminated the entire row of wide windows and replaced them with much smaller windows to ensure optimal preservation of privacy. To continue, point 5 reveals a much significant downsizing of the kitchen's window due to the fact that it is a more privacy-demanding space due to its occupants.

Finally, although the modifications made by the residents were detrimental to the building's façade, and quite probably against architectural laws; we can only blame them to a certain extent since their needs, cultural background, and requirements weren't taken into consideration at all in the design process of the dwellings in question. Therefore, a post-occupancy evaluation process and a feedback approach would be vital to future housing projects.

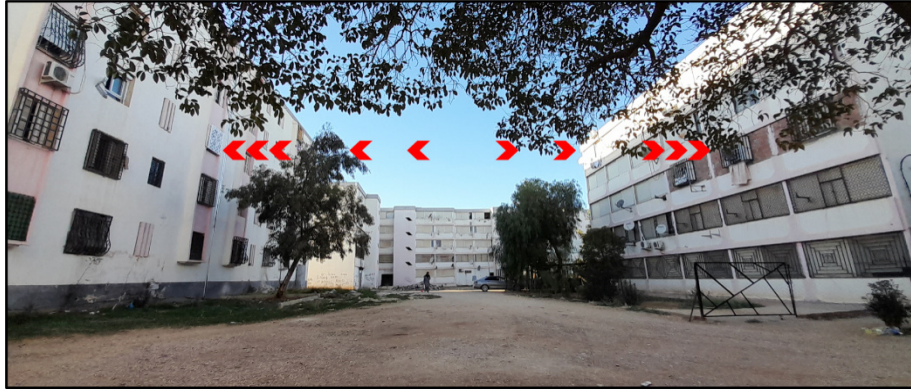
Figure 25. Privacy problems that led residents to modifications. Source : Author, 2022.

Additionally, (Figure 25) offers a clearer view of the situation, it is shown that the residents suffered from a “face to face” problem with the neighboring building, thereby, a privacy problem on a cultural level, which drove the actions of the residents to downsize the several wide windows.
