# Assessment of Humidity Effects in Algerian Residential Buildings: Case of Guelma

This paper evaluates indoor air quality in residential buildings affected by humidity and investigates its impact and effects on hygienic comfort. Using a comparative methodology, we explored the negative impact of humidity in indoor air on hygienic comfort based on measurements of relative humidity (RH) during two periods (summer-winter) inside two apartments in residential buildings in the GahdourTahar neighborhood located in the city of Guelma (northeast Algeria). We also assessed the state of indoor air by observing the physical pathologies in the buildings studied. Indeed, the humidity level observed in the two apartments studied contributes strongly to pathogenic contamination through the production of mold and fungi, which directly affects the safety of the building. This study aims to remedy and correct the inadequacy of natural ventilation to facilitate the elimination of indoor humidity that can affect the hygienic condition of the building. Thus, the maintenance of an optimal RH must be sought to ensure the integrity of the building elements and the comfort of the inhabitants.

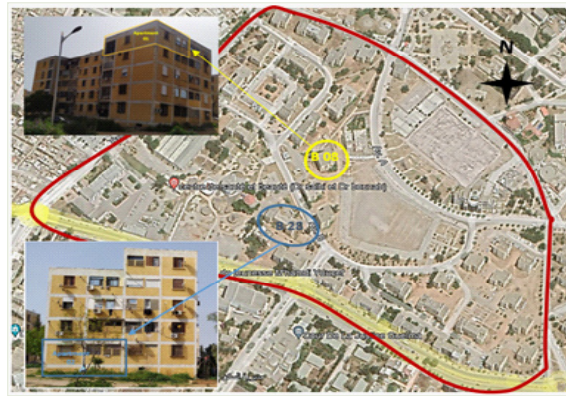
Two apartments (containing three rooms: a living room and two bedrooms) were chosen as case studies. They are located in two collective buildings of five floors in the GahddourTahar neighborhood (Guelma, Algeria). The first apartment oriented to the North-West / South-West is located on the top floor of building 28. It is a bar-shaped building with four apartments per floor. While the second oriented to the North-East is located on the first floor of building 08; it is a corner building containing three apartments per floor.

**Figure 1.** Gahdour Tahar neighborhood and apartments studies. (Source: Google Earth, modified by the Authors, 2021)

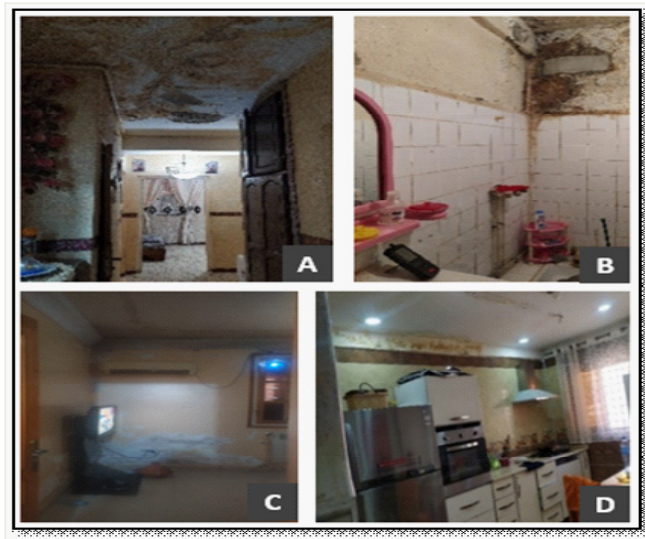
From our observation, we found damp stains (black stains, visible traces, flaking coating, etc.) on the walls, ceilings, and behind the cupboards of the apartments studied. At the same time, we found cracks in several places in these dwellings (Figure 2). These signs are due to the increase in humidity inside the apartment and the accumulation of mold, fungi, and bacteria. These harmful agents cause the degradation of certain materials, the degradation of pipes, cracks, and other damage to the building (Psomas, 2021). It is noted that the bathrooms and cold walls poorly oriented that do not have sufficient sunlight or adequate ventilation are the places most threatened by traces of humidity. To understand the sanitary condition of the apartments studied from the observations on the surveyed apartments, we can say that these apartments are degraded; they suffer from the development of significant mold caused by the increase in the degree of humidity. This situation threatens the integrity of the building and the well-being of the inhabitant.

Figure 2. Damp stains observed in the apartment. (Source: Authors, 2021)

By comparing the humidity level measured with the Air Quality tester JD-3002 instrument with the observations made on the buildings studied, we found a balance between the answers of the inhabitants and the measurements made. Our investigations show that the humidity levels are very high during the winter compared to the summer period. They exceed the regulatory values, especially in the apartment located on the first floor. It should be noted that the highest humidity values are found in spaces that do not have sufficient sunlight or adequate ventilation. In these same spaces, we observed the presence of traces of humidity represented by black spots, detachment of coating, etc. They give off unpleasant odors affecting the comfort and well-being of the inhabitant.

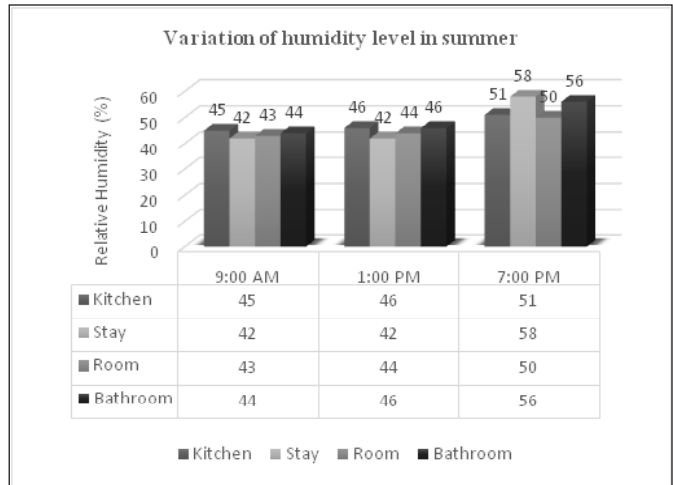
Figures 3 and 4 show the variations in relative humidity inside the different spaces of the studied apartments during the summer period, while Tables 1 and 2 illustrate the temperature measurements.

Figure 4. Variation of humidity in different zones of apartment 2. (Source: Authors, 2021)

According to the literature, the optimal relative humidity is between 30 and 50%. Depending on the time of year and the indoor/outdoor temperature (Levasseur et al., 2017). According to ASHRAE 55-81, the relative humidity should not exceed 70% at an ambient temperature of 22.6°C and 60% at 26°C. Specifically, Tsutsumia et al. (2006) noted the relative humidity in the apartment should be between 35% and 60%, which can maintain comfortable conditions (Romana et al., 2016). By adhering to this range, it appears that in the first apartment on the fourth floor, the humidity levels measured in the summer remained in the comfortable range. On the other hand, in the second apartment on the first floor, the humidity values measured in the same period exceeded the recommended values, especially in the bathroom and living room, where they were 56% and 58%, respectively, in the evening.
